# Landfill Leachate Disposal with Irrigated Vetiver Grass

**Abstract:** Stotts Creek Landfill is a major waste depot of the Tweed Shire receiving wastes from both Tweed Heads and Murwillumbah townships and neighboring local government areas. Disposal of leachate is a major concern of the Shire as the landfill site is close to agricultural areas. An effective and low cost leachate disposal system is needed, particularly during summer high rainfall season.

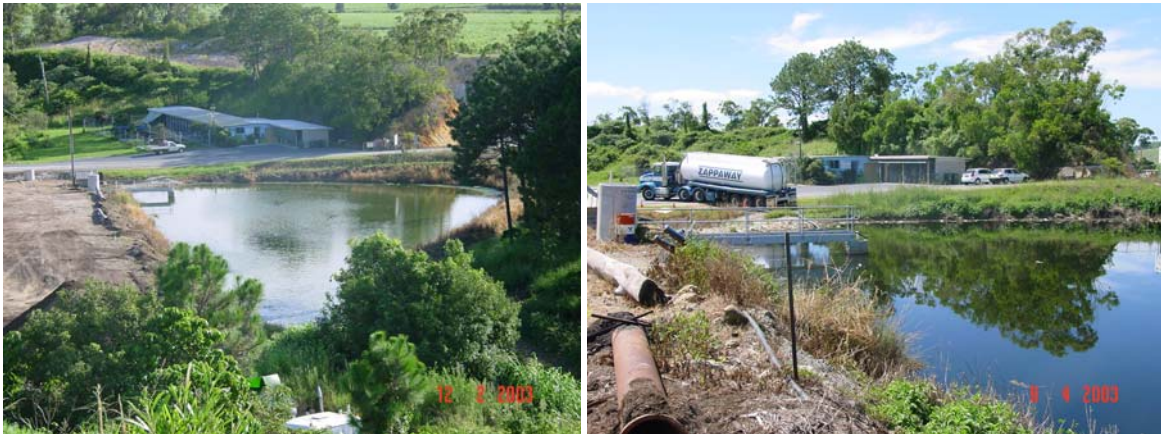
**Photo 1: Leachate pond and excess leachate is taken away during high rainfall period**

Currently both leachate and surface water are separated where possible to reduce the volume of leachate. The surface water is discharged to local streams via an artificial wetland, which was constructed to help improve the water quality leaving the site. The leachate is stored in a dam in the lower portion of the site and is irrigated onto completed and partially completed sections of the landfill to provide for evaporation and transpiration into the atmosphere. The amount of leachate able to be disposed of by this method is limited, particularly during high rainfall periods. During periods of heavy rainfall, excess leachate has to be transported off site to Council's effluent treatment plan. Although this practice is very inefficient and costly, it has to be done for Council to comply with Environment Protection Authority License Conditions. Therefore effective disposal of leachate is a major concern to Council (Photo 1).

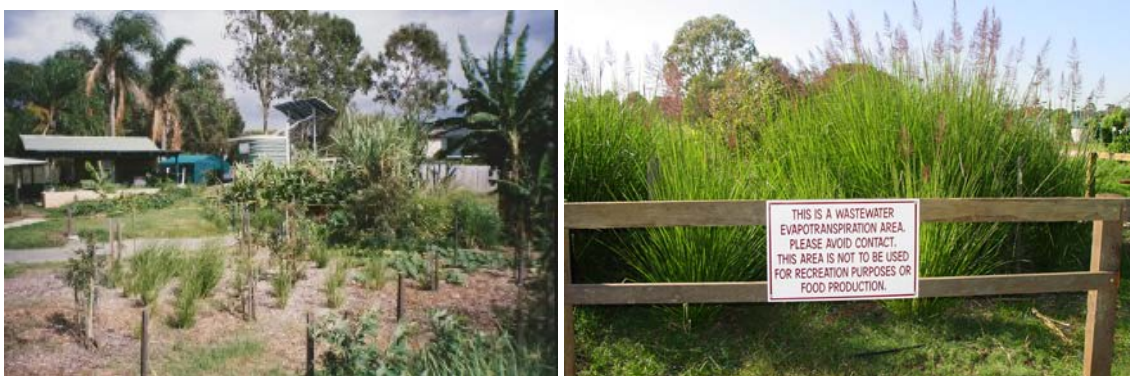
**Photo 2: Left, new vetiver planting to treat sewage effluent from a septic tank, Right, 8 months later, vetiver completely absorbed all the effluent discharge**

A demonstration site was set up in Brisbane to treat effluent discharged from a septic system. Vetiver grass was selected after the failure of other plants including a variety of fast growing tropical grasses and trees, and crops such as sugar cane and banana to absorb the effluent discharge from the septic tank on a public park. After five-month growth, vetiver was more than 2m tall and a stand of about 100 vetiver plants in an area less than 50m<sup>2</sup> have completely dried up the effluent discharge (Photo 2).

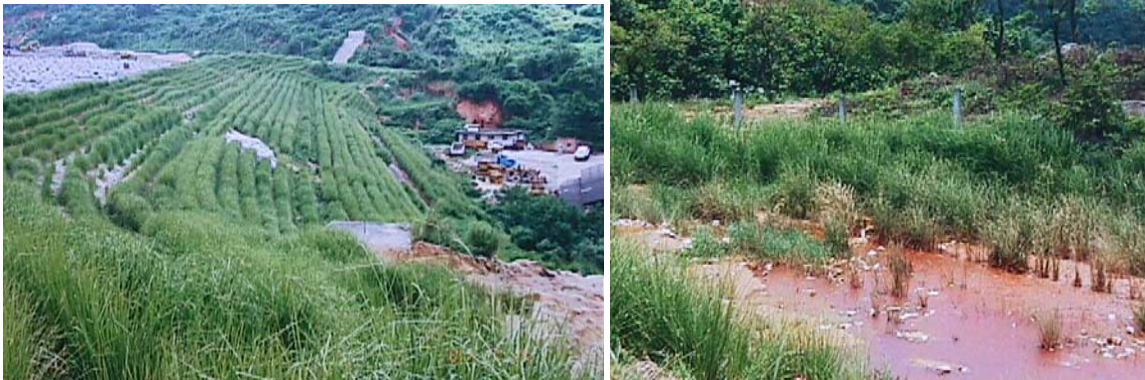
**Photo 3: *Left*, Vetiver planted for leachate seepage control and dam wall stabilisation  
*Right*, Vetiver grew well in toxic leachate pool while other plants died.**

Vetiver was planted in November 2000 to stabilise the dam wall and to reduce seeping leachate. Despite the extremely poor soil (crushed weathered rock, highly compacted and extremely poor in nutrients) vetiver established and not only succeeded in stabilizing the dam wall, it has also dried up leachate seepage. Vetiver also grew well on the edge of highly toxic leachate pools; both native and introduced plants were killed. (Photo 3) (Xia *pers. com.*). In Thailand vetiver was also used successfully to treat landfill leachate seepage.

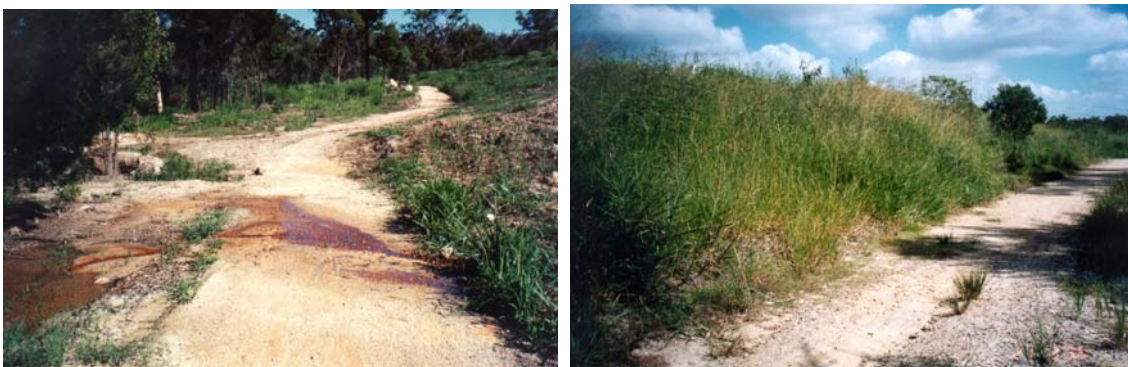
**Photo 4: *Left*, Toxic leachate seepage at the foot of an old landfill at Cleveland  
*Right*, One year after planting, Vetiver grew well and dry up the seepage**

VS has also been used successfully to treat leachate from landfill seepage in Cleveland (Photo 4) and Port Douglas in Queensland; Armidale City (Photo 5) and Lithgow City in New South Wales.

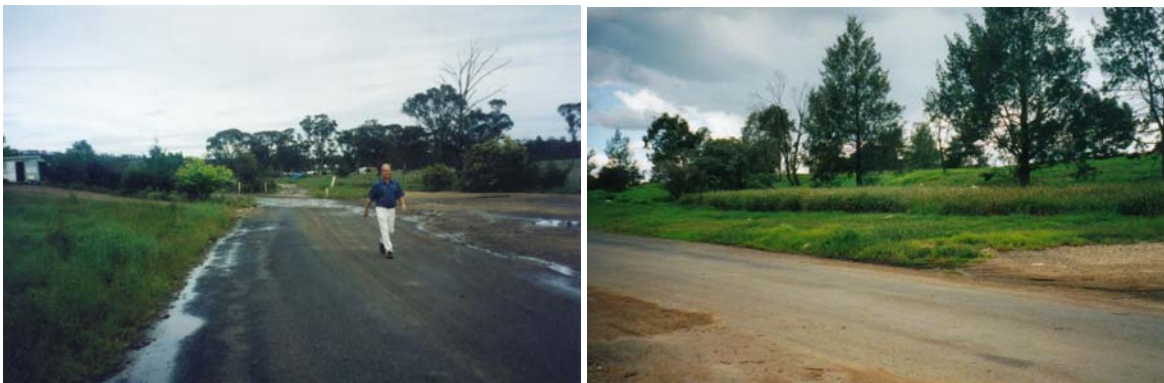
**Photo 5: *Left*, Toxic leachate seepage at the foot of a working landfill at Armidale  
*Right*, One and half year after planting, Vetiver grew well and dry up the seepage**

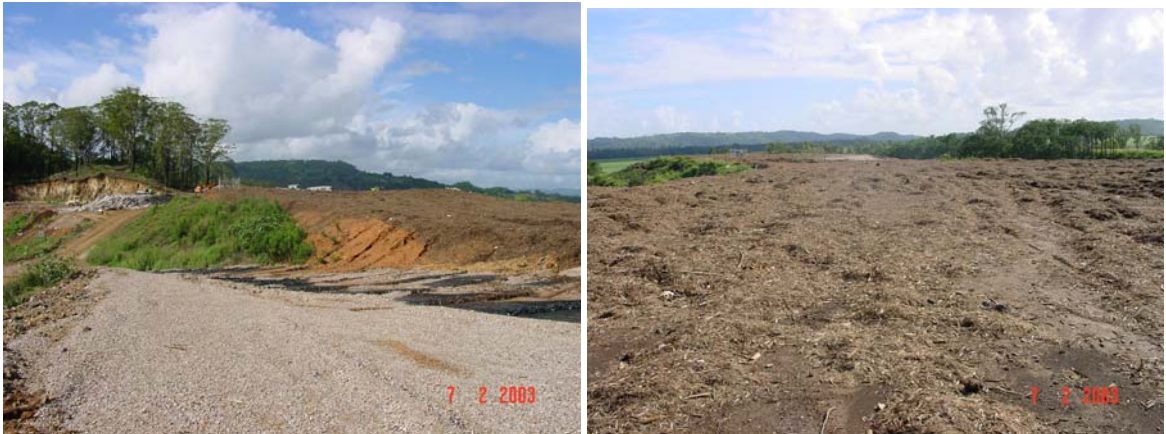
**Photo 6: Side view (left) and top view (right) of the landfill mound, which has been mulched.**

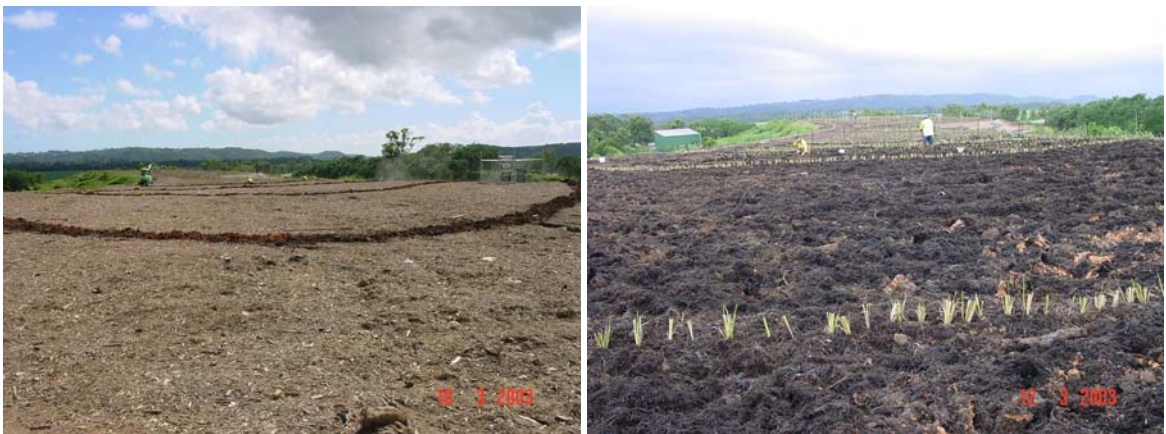
**Photo 7: Contour lines marked before planting (left) and after planting (right) on the mound**

The whole area was first surveyed and contour lines marked out before planting. Due to the thick layer of mulch, a small backhoe was used to mix up the mulch and topsoil for planting (Photo 7)

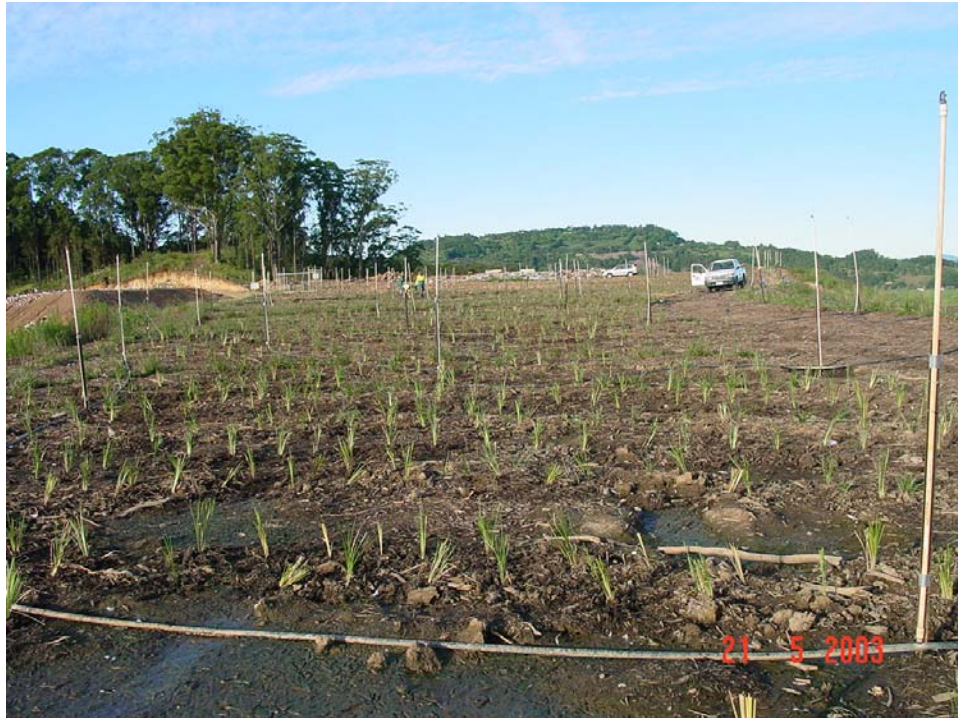
**Photo 8: Random planting between contour lines**

- Thick contour hedges (10 plants/m) to spread runoff and irrigation water, the contour lines were planted at 0.5m Vertical Interval. Vetiver tube stock was used for the contour lines planting.
- Random pattern in the areas between the hedges planted with bare root slips (Photo 8).

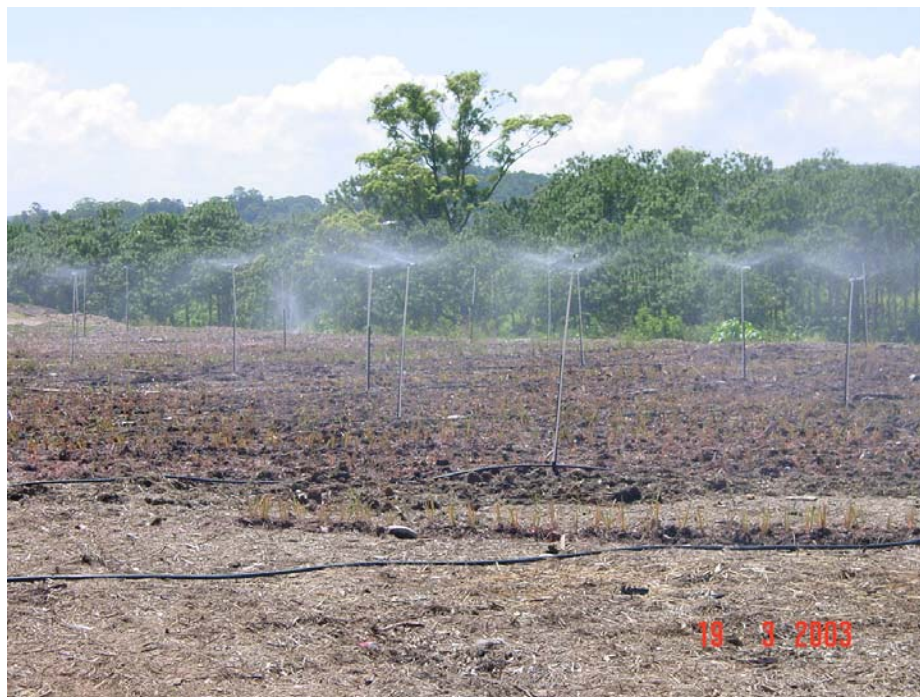
**Photo 9: Vetiver was irrigated with leachate immediately after planting**

An overhead spray irrigation system was installed and used immediately after planting each day. This system has a capacity of delivering 1 300L/minute (Photo 9).

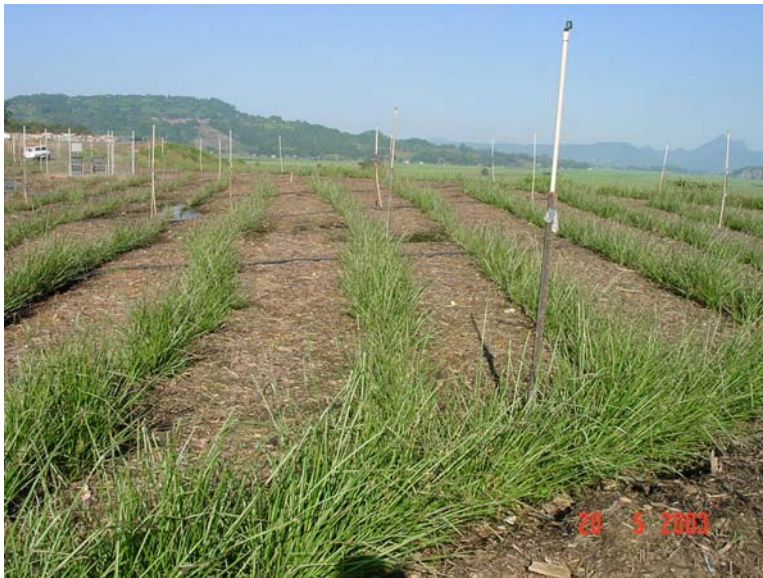
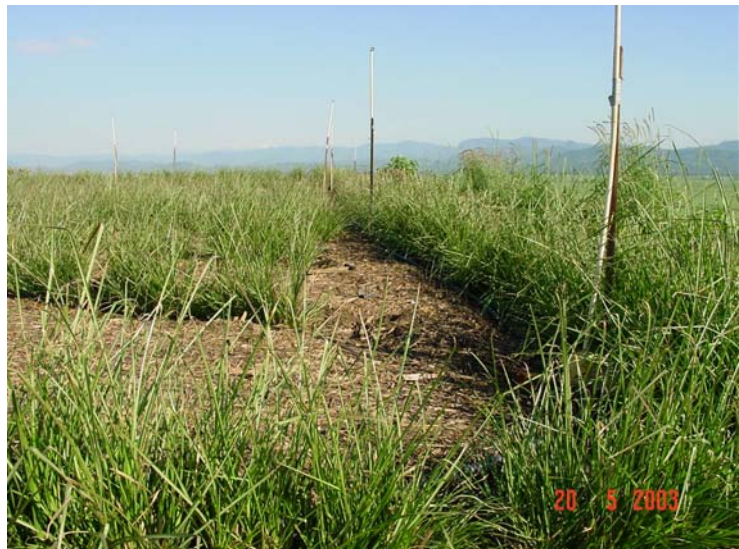
**Photo10:Excellent establishment and growth three months after planting.**

Excellent establishment was obtained on the contour lines with potted vetiver (100%) and very good rate (90%) were also achieved with bare root slips (Photo 10).
